DETERMINING THE EFFECT OF SUPER FINE TILLITE FILLER IN AN ASPHALT LAYER

E HORAK* and S EMERY**

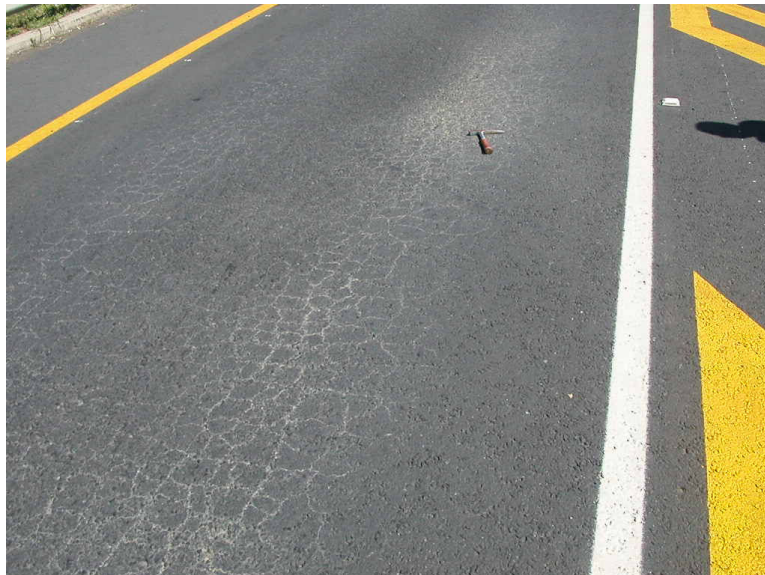
During the project construction period, limited areas of distress on the earliest sections were evident. The first visual surveys indicated that the surfacing showed signs of dryness, brittleness, and an increase in porosity and permeability. The extent of the area affected grew to cover most of the 22km length of the project. Over the following months, further deterioration occurred in the form of rolled-in chip loss, aggressive stripping of binder from surface stone, white fines pumping after rain, crocodile cracking and release of more white fines. The final stage of visually observed surface related deterioration appeared like crocodile cracking with obvious signs of water intrusion into the under laying base.

Image of typical early cracking, fines occurrence and crocodile type cracking on a section of the road (August 2003)

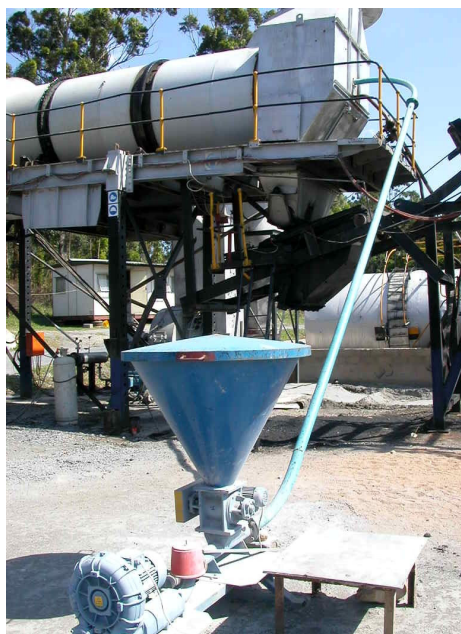
The drum mix asphalt plant was still operating when the investigation started.

Lime was initially added via the aggregate conveyor belt (probably during the trial mix laying). It was later added with a pump and pipe system. The plant had no baghouse fines filter system, but instead a cyclone dust collector system which sucked off dust and air right at the point where the feed-in pipe for the lime addition was positioned as can be seen clearly in the photo alongside.

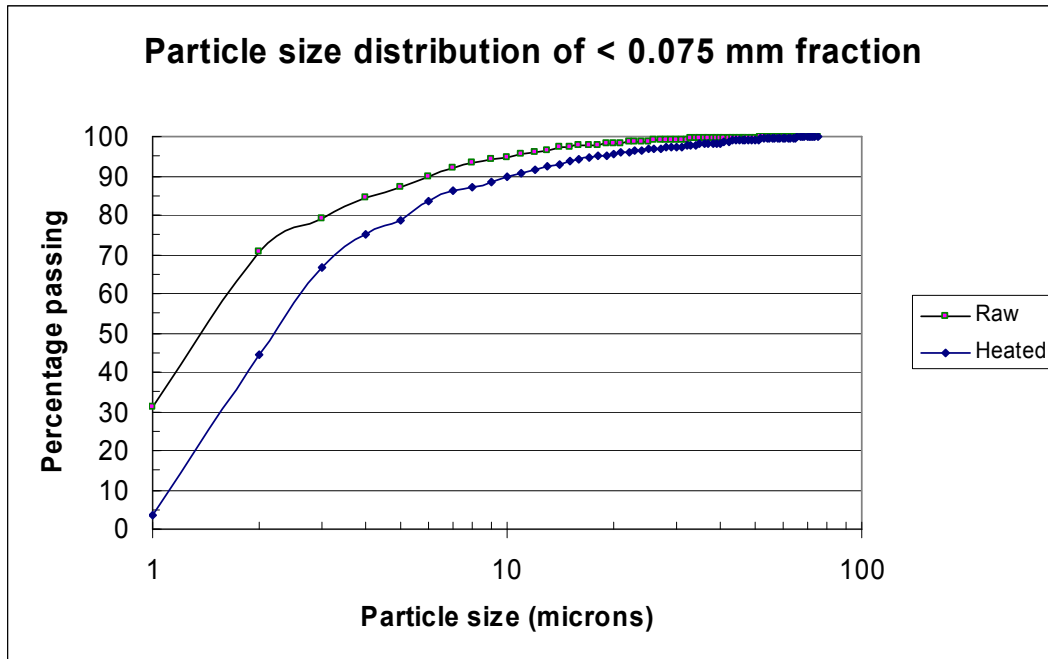
Figure 1. Grading of the tillite filler material.

A series of additional tests on tillite samples from the quarry were done by the CSIR laboratories. These tests involved a modified Texas Ball Mill test series, where steel balls, water and heating of the sample were varied. It also involved water absorption tests and sand equivalent tests (standard and extended). These tests showed no unusual results and are not discussed here. However, the grading of the tillite filler portion produced by laboratory crushing (heated and raw) showed an extremely fine gradation determined by laser technology. Up to 90% were less than a diameter of 10 micron in both the raw and heated condition (i.e. were in the super fines size range). The grading of this material thus produced is shown in Figure 1 to follow. This super fine fraction reflected that the geological origin of tillite was fine rock flour and indicated the potential for producing super fines in asphalt during the abrasion action of mixing.
